# Supporting Guinea Pig Dental Health in Practice

## Identifying good dental health

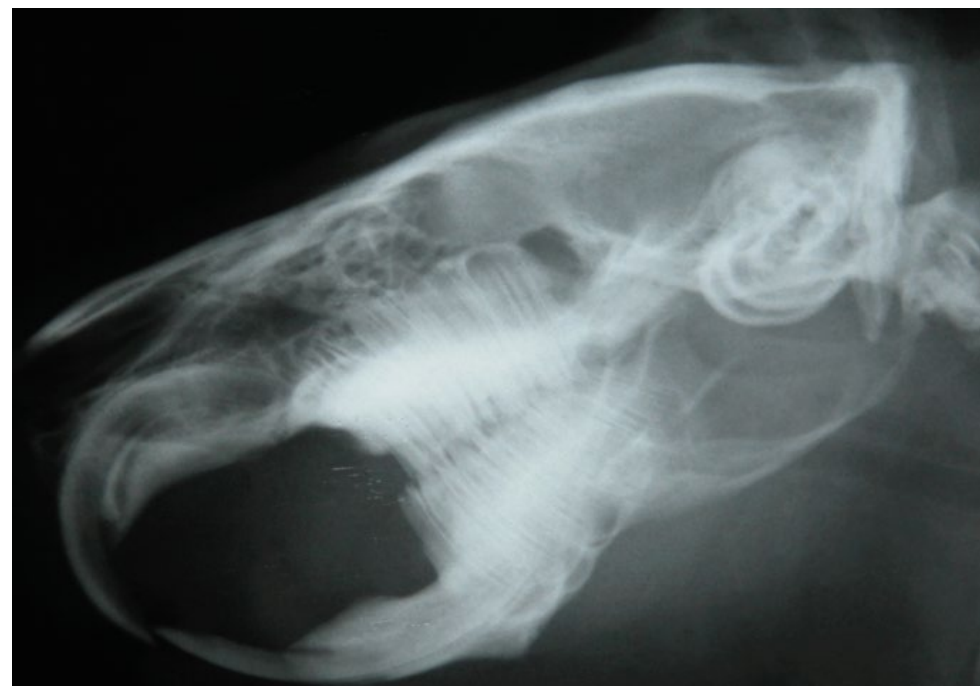
Normal latero-lateral skull radiograph showing molars engaged; incisors with a gap, but at correct angles. There is no evidence of molar spurs or of tooth elongation or root overgrowth.

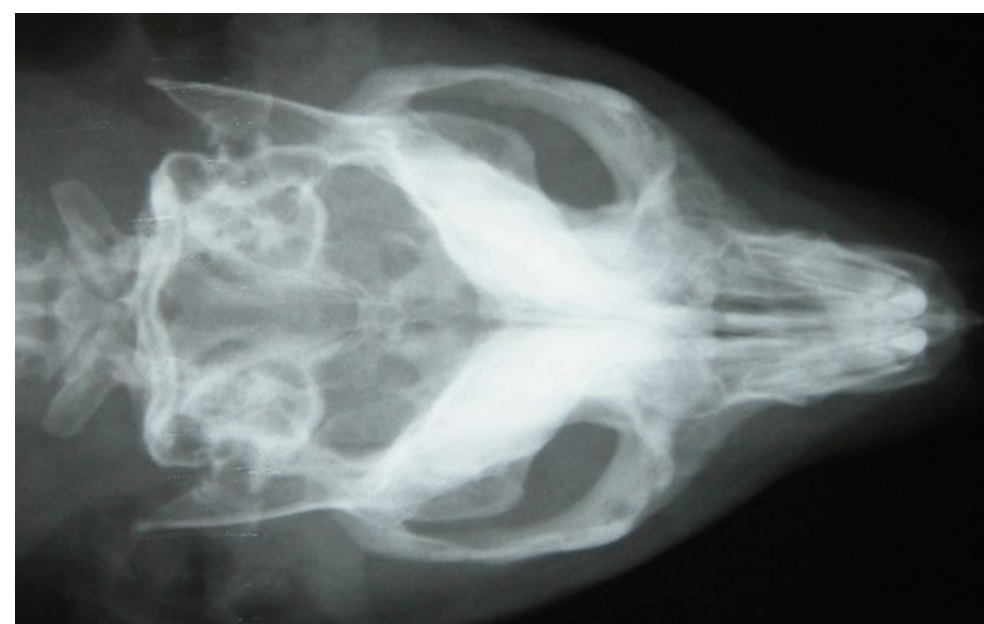
Dorso-ventral view of the same normal guinea pig.

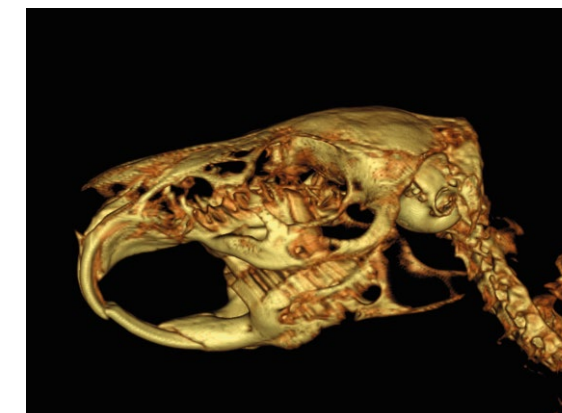
### Moderate

3D CT reconstruction shows root elongation and some penetration of the mandibular cortex

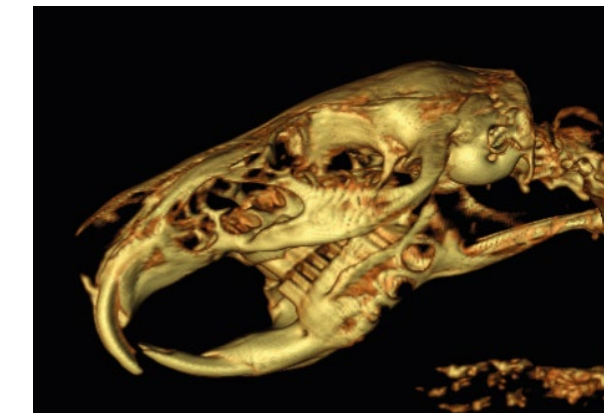
### Severe

The incisors are now elongated and engaging at the same time as the molars; incisors are losing their normal chisel-shape and meeting "end on". Molar roots are elongated and penetrating bone cortices

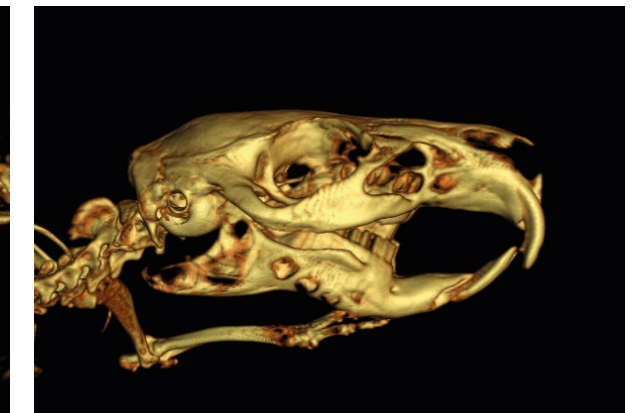
### More severe

Further molar root elongation and bone cortex penetration

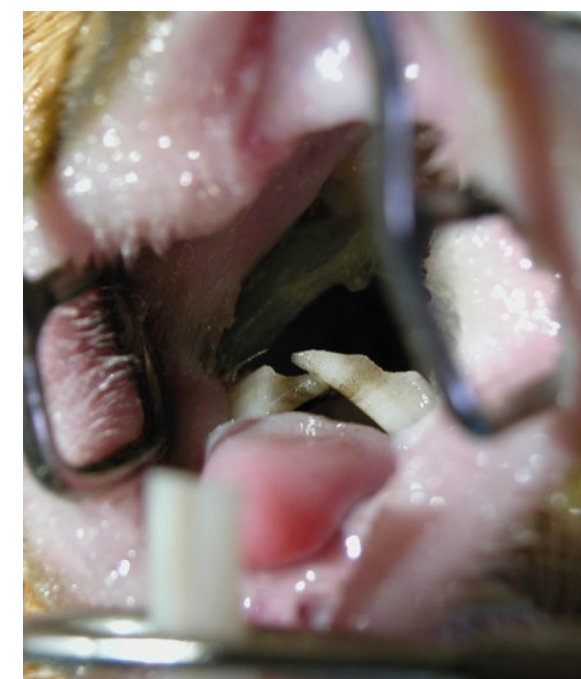
Overgrowth of molars leading to bridging over the tongue and difficulty prehending food, chewing and swallowing.

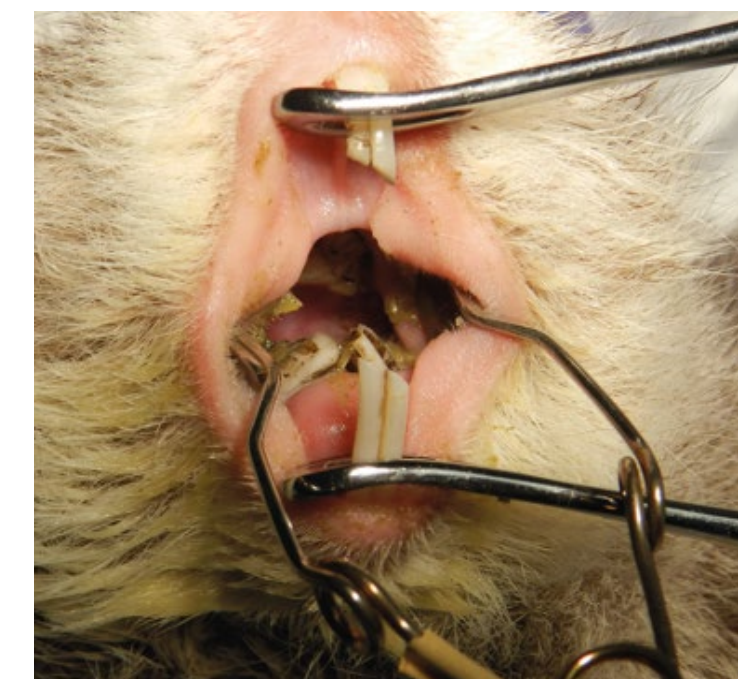
Molar bridging as picture left. In this case the incisors are meeting on the slant. This shows uneven chewing and is a major clue on examination that there is either molar dental disease or temporo-mandibular joint disease or ear disease.
